TEST REPORT

Report No.: THSH20123028662EN

Sample Description : Transmitter instrument housing

Test Requested : IP67

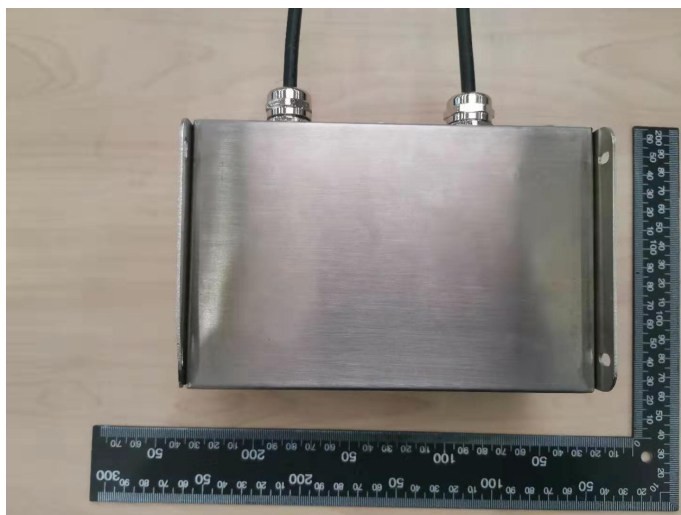
SAMPLE PHOTO

Sample Material : Die-cast aluminum alloy housing

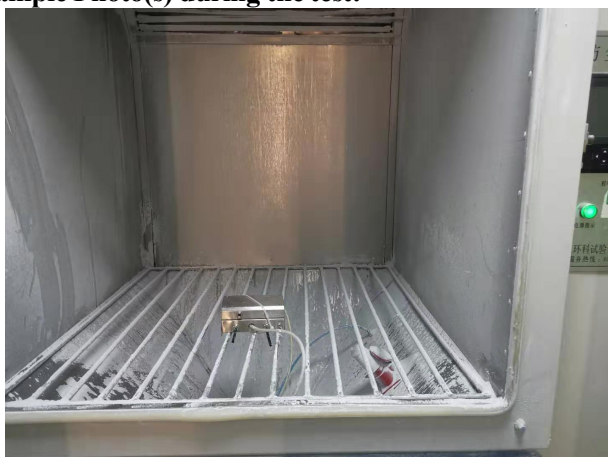
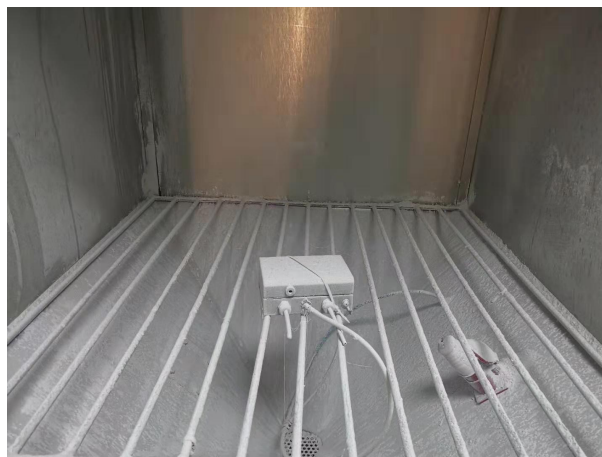
Sample Photo(s) during the test:

Test setup: Dust-proof chamber, Model No. SC-010

Test Conditions: 1) Maximum depression : 2kPa.
2) Test period: 8 hours
3) Extraction rate: 40 volumes per hour

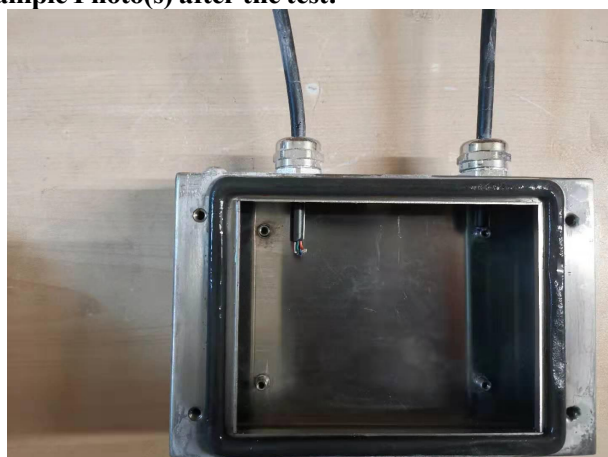
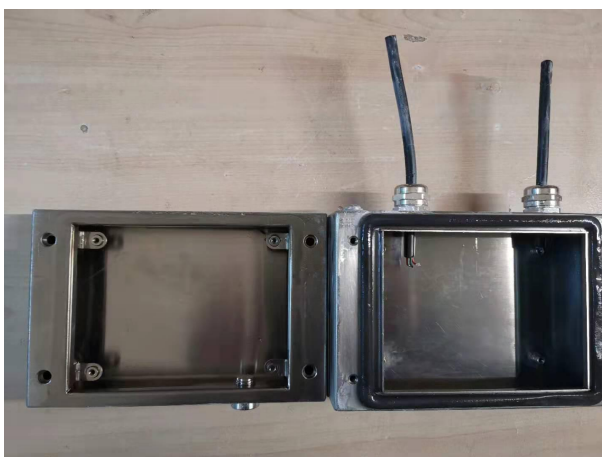
Sample Photo(s) after the test:

Sample Name	Test Results
Transmitter instrument housing	No dust observed inside the test sample

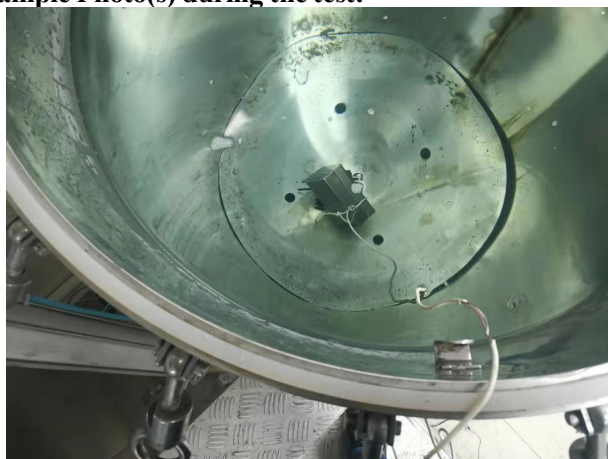
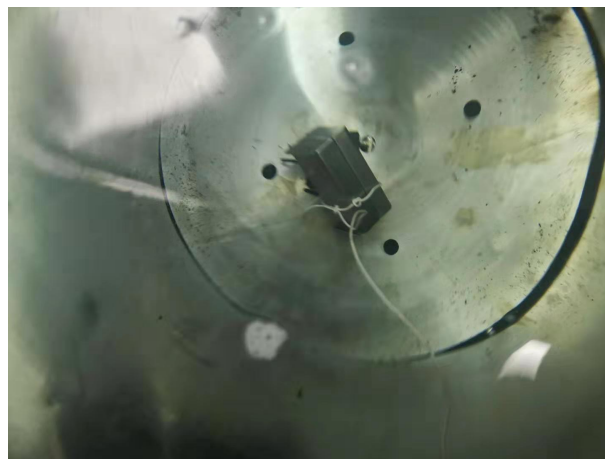
Sample Photo(s) during the test:

Test setup: Water proof test chamber, Model No. IPX1-8

Test Conditions: 1) Depth of water: 1m
2) Test period: 30 min

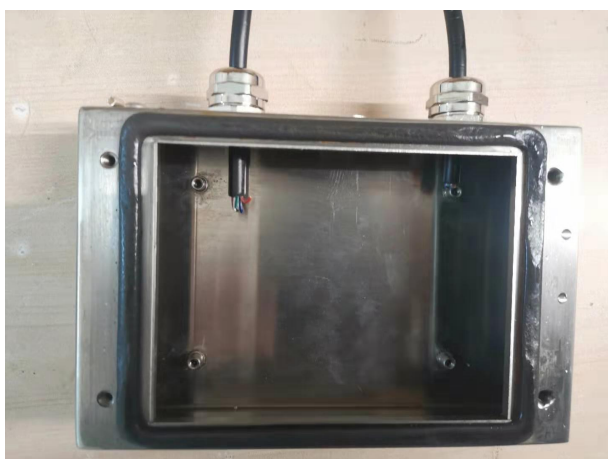
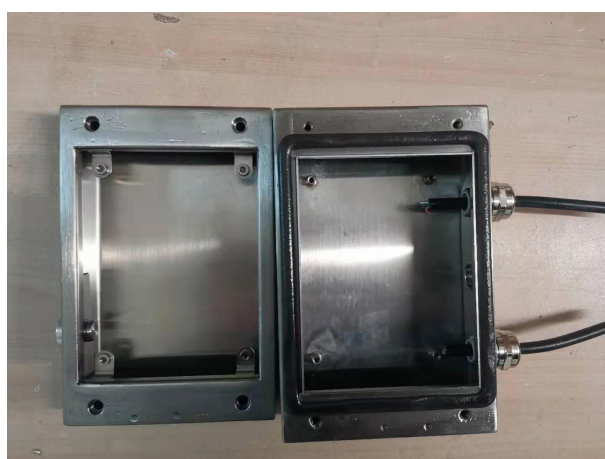
Sample Photo(s) after the test:

Sample Name	Test Results
Transmitter instrument housing	No Water entered the cavity of sample after this test
